WALL-TO-WALL HOME INSPECTIONS, LLC

## RESIDENTIAL INSPECTION

1234 Main Street  
West Linn, OR 97068

01/25/2025 9:00AM

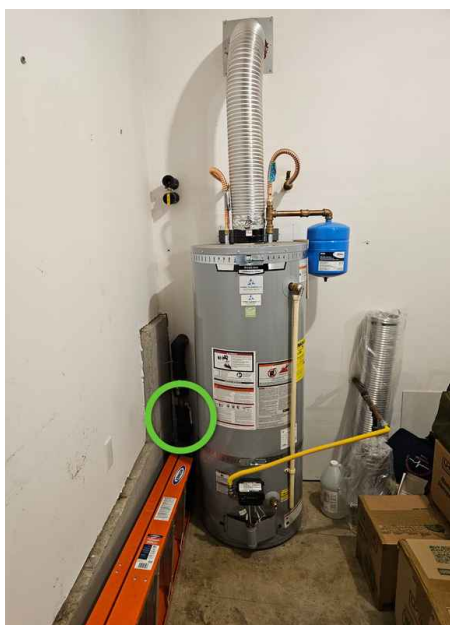
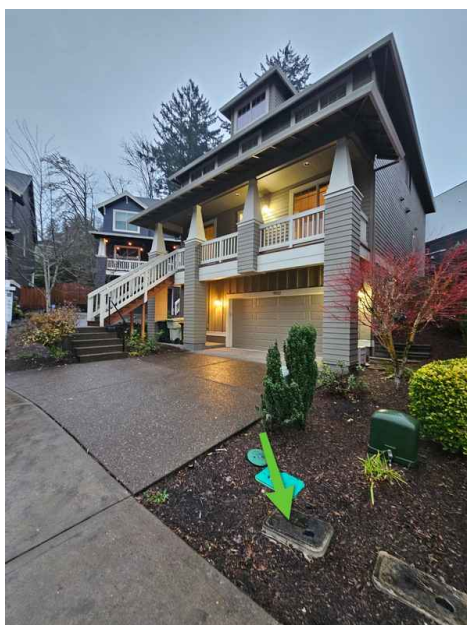
**WATER SHUT-OFF LOCATION(S): A. Main Water Shut-Off Location(s) Pictured:**

Curbside & Garage

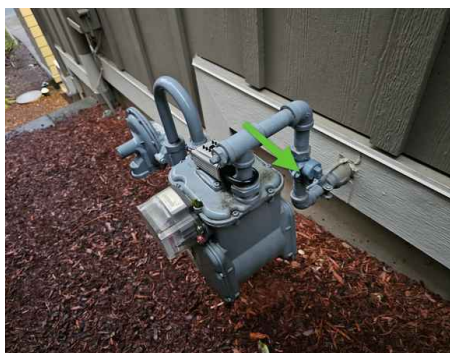
**FUEL SHUTOFF LOCATION(S): A. Fuel Shut-Off Location Pictured:**

West Exterior

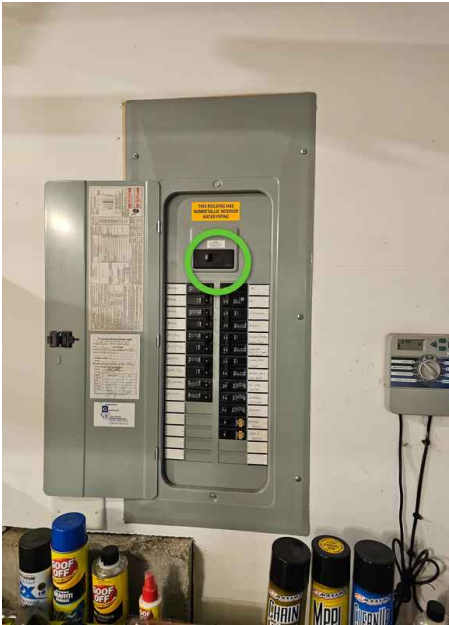
**ELECTRICAL SHUTOFF LOCATION(S): A. Electrical Shutoff Location(s) Pictured:**

Garage

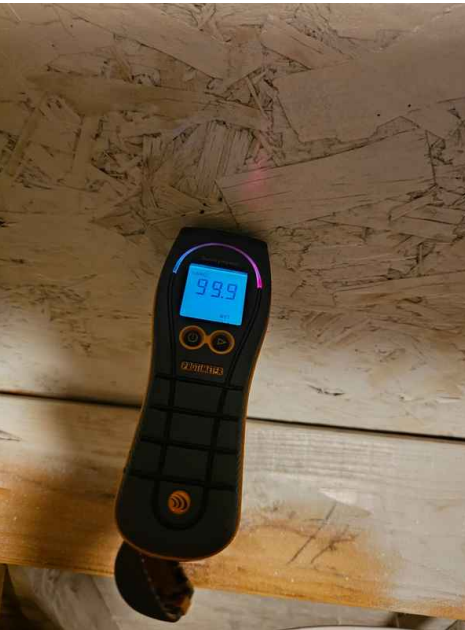
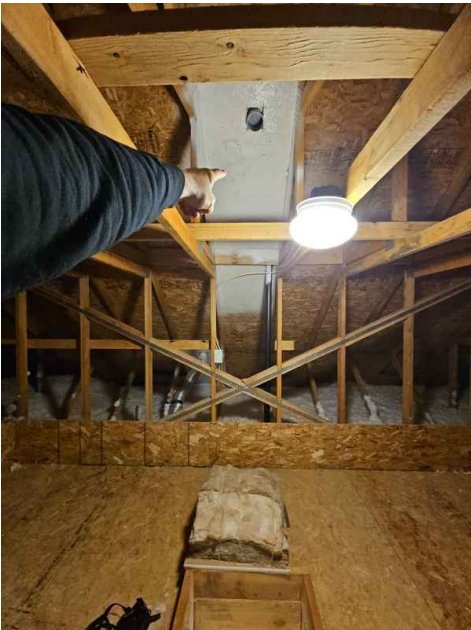
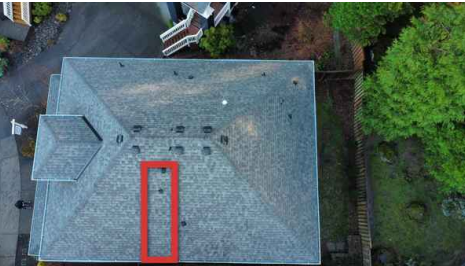
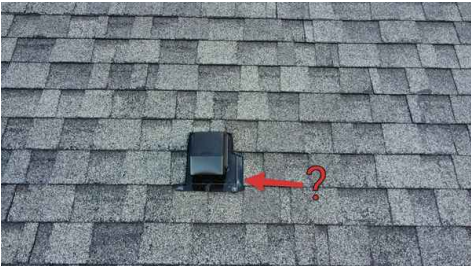
West Attic

3.1.1 MOISTURE EVIDENCE

MOISTURE ELEVATED

Elevated moisture levels were noted at the time of inspection. High moisture levels provides an opportunity for mold growth. Recommend a qualified licensed specialist to evaluate the entire system and make all recommended repairs.

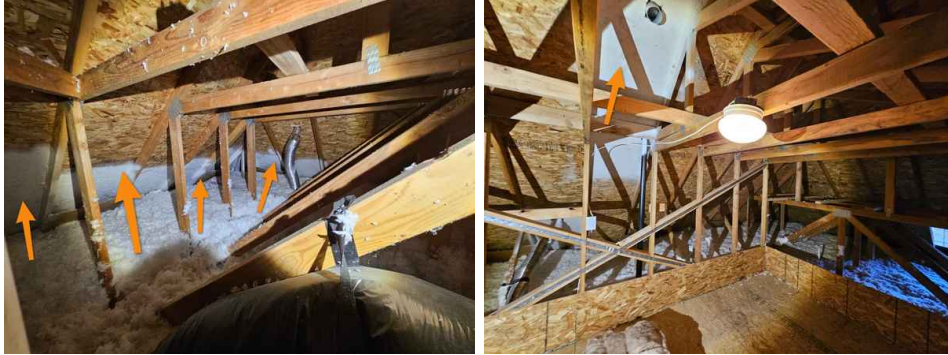
## 3.1.2 MOISTURE EVIDENCE

**MOLD MITIGATION SPRAY NOTED**

There is paint covering the sheathing and some framing. This is typical mold mitigation. Recommend a qualified licensed specialist to re-evaluate and make all recommended repairs. Recommend asking about a possible warranty contract from mold remediation company that did the work.

Contact a qualified environmental specialist

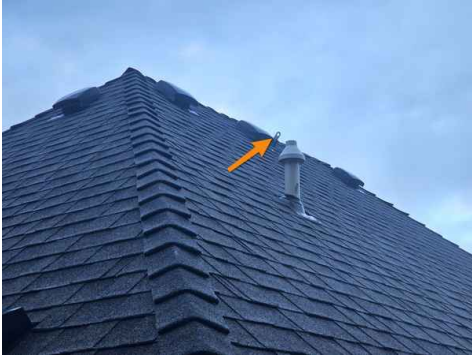
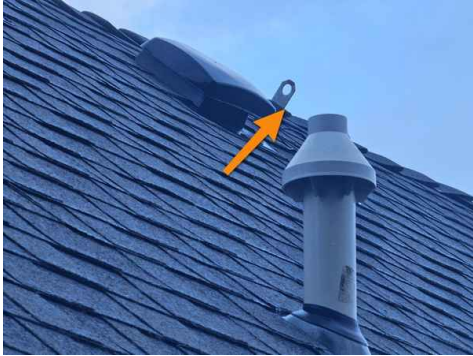
East

**TIE-OFF CAP MISSING**

The tie-off cap appears to be missing. This can allow for water to enter. Recommend replacing.

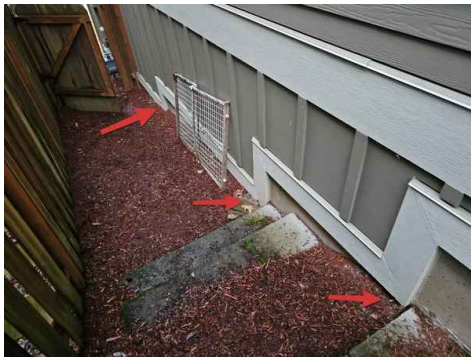
West

Soil/grade does not have proper clearance from siding. Siding wicks moisture from the soil, which can cause rot. Recommend grading soil 6 inches below or away from siding. Recommend a qualified licensed specialist to re-evaluate for further damage and make all recommended repairs.

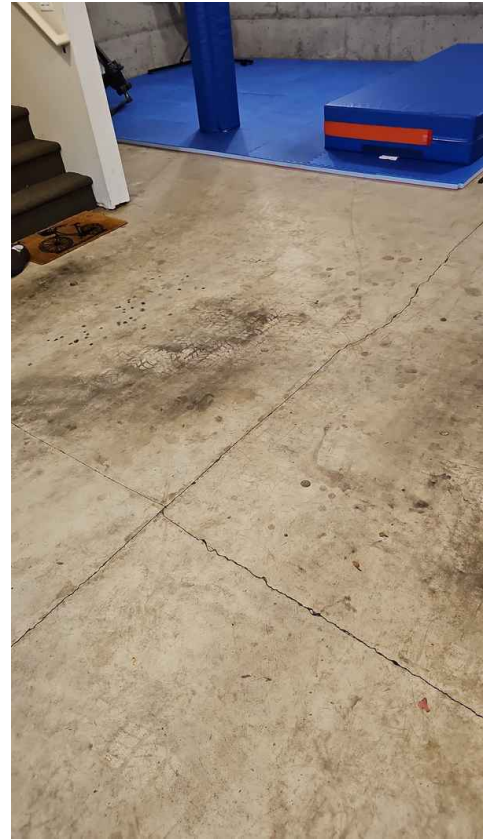
#### TYPICAL CONCRETE CRACKING

Typical cracking on concrete. Large slabs of concrete are almost guaranteed to have drying and settling cracks. If the cracks get large enough that a quarter can fit in them, we recommend having them sealed so that moisture doesn't damage the substrate. May want to have a qualified licensed specialist to re-evaluate for further damage and make all recommended repairs.

Contact a qualified concrete specialist

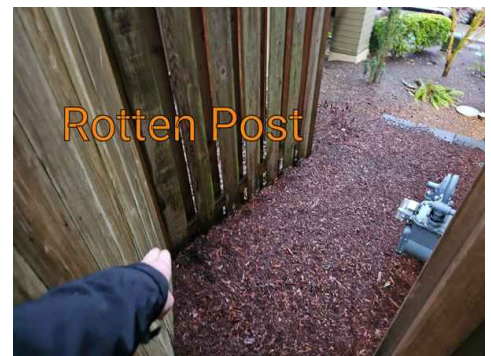
West

### 6.5.1 FENCING

#### DEGRADED/DAMAGED/MISSING FENCING/GATE

Although fencing is not part of a home inspection, we observed that the fence, and/or gate, has degraded and/or damaged components. Recommend a qualified licensed specialist to re-evaluate for further damage and make all recommended repairs.

Contact a qualified fencing specialist

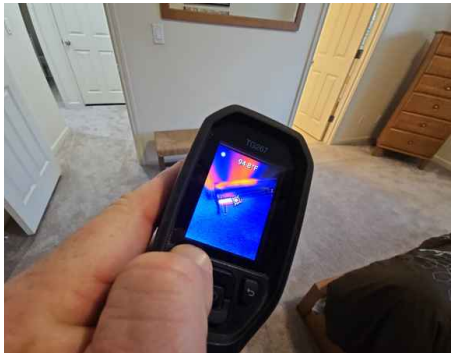
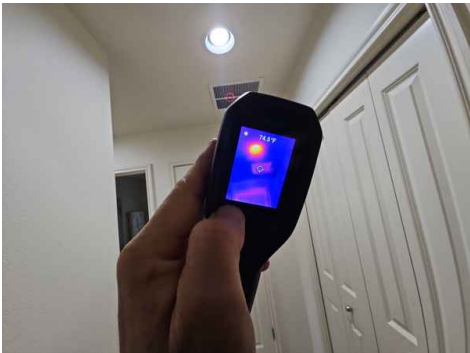
**INFORMATION: F. Heating Temperature Differential (Infrared Readings Included):**

Primary

Air Intake (Room Temperature)

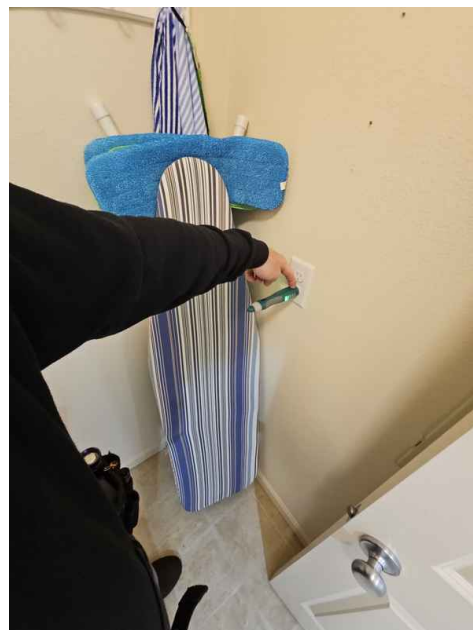
Laundry

**Health, Safety, Structure, Moisture, Pest****GFCI MISSING**

**Safety Concern:** Current safety standards require ground fault circuit interrupters (GFCI) to be outside, kitchens, bathrooms, garages, laundry rooms, unfinished basements, etc.. Recommend updating to GFCI outlets or circuits to improve safety, and having a licensed electrician add.

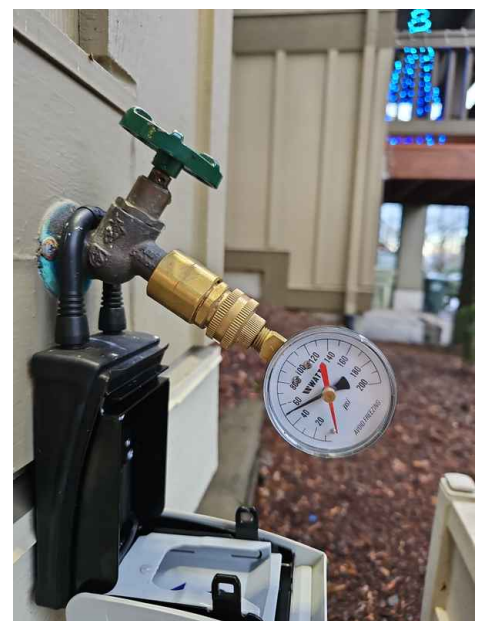
**WATER SUPPLY SYSTEM: D. Water Pressure Reading From Hose Bib (Pictured):**

Satisfactory

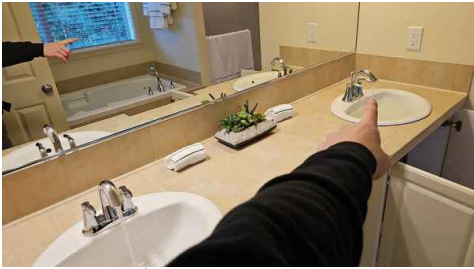
Primary Bathroom

The water pressure is low when more than one fixture is being run in the house. Recommend re-evaluation.

Contact a qualified plumbing specialist

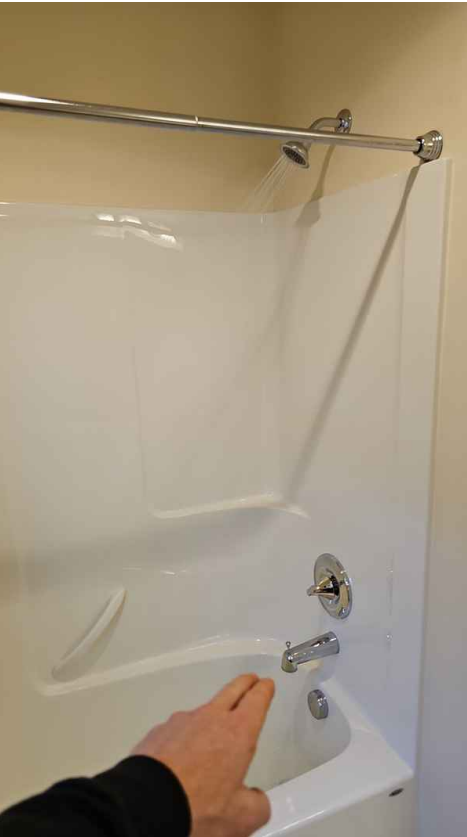
Upper Level Hallway Bathroom

The shower diverter valve is letting a lot of water by, rather than diverting the water to the shower head. Recommend cleaning or replacing.

Contact a qualified handyperson/diy

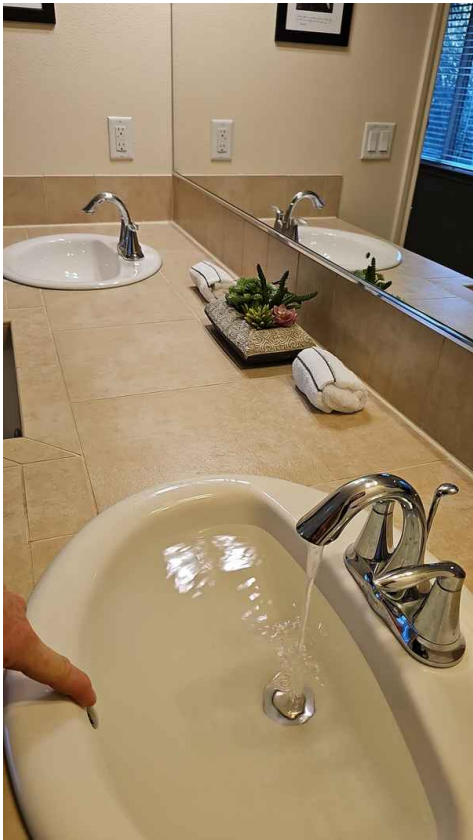
Primary Bathroom

One of the overflow drains appears to be clogged. Recommend re-evaluation and all needed repairs.

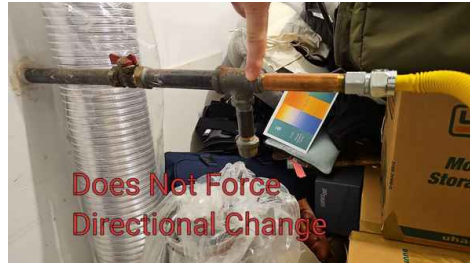
**DRIP LEG/SEDIMENT TRAP MISSING/INCORRECT**

Safety Concern: Recommend having a licensed plumber or HVAC contractor correctly install the gas drip leg.

Contact a qualified hvac specialist

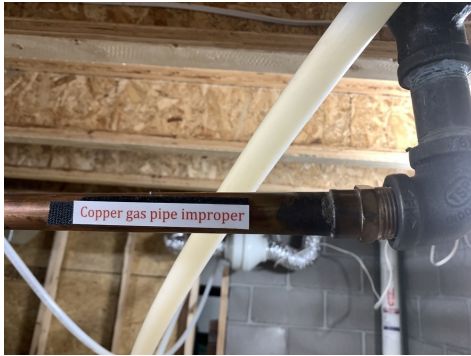
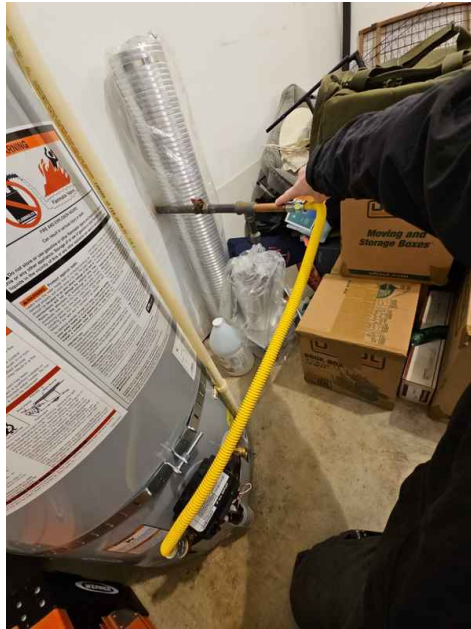
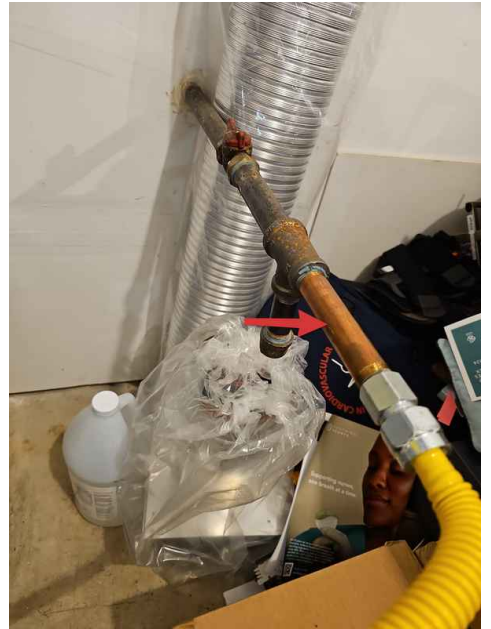
**GAS LINE, COPPER**

Safety Concern: Copper piping is being used as a gas line. This has never been allowed. Recommend a licensed plumber to reevaluate the entire system and repair.

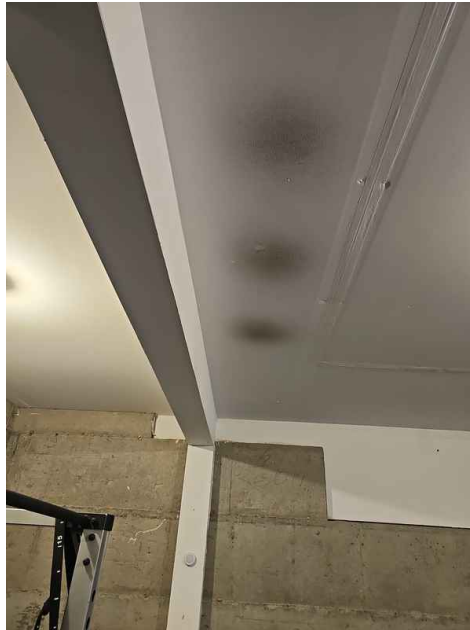
Discolored walls or ceilings were noted in one or more areas. Appears dry at the time of inspection and does not appear to be moisture related.

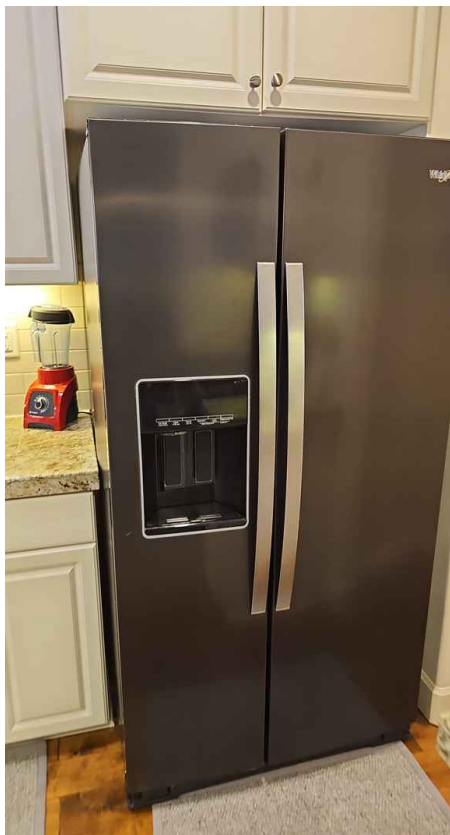
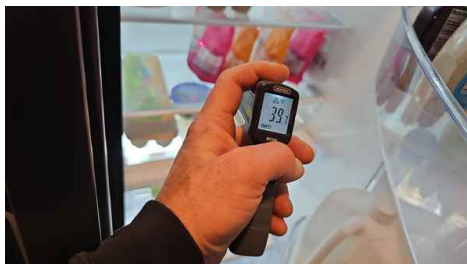
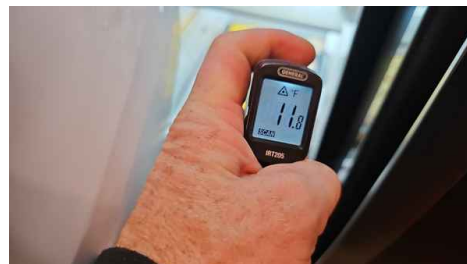
**REFRIGERATOR:** Refrigerator Operated Under Normal Cycle & Condition Where Visible:  
Satisfactory

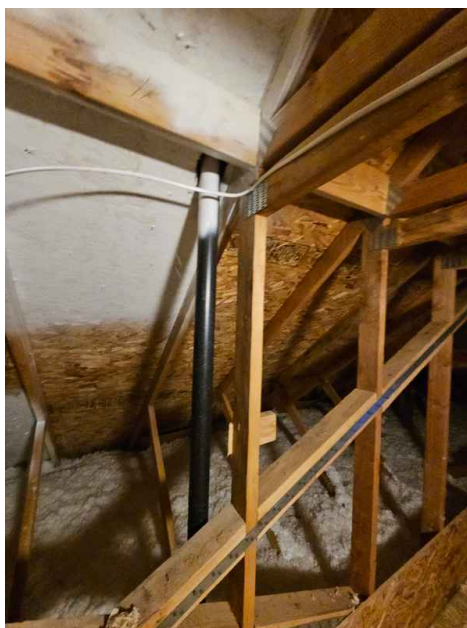
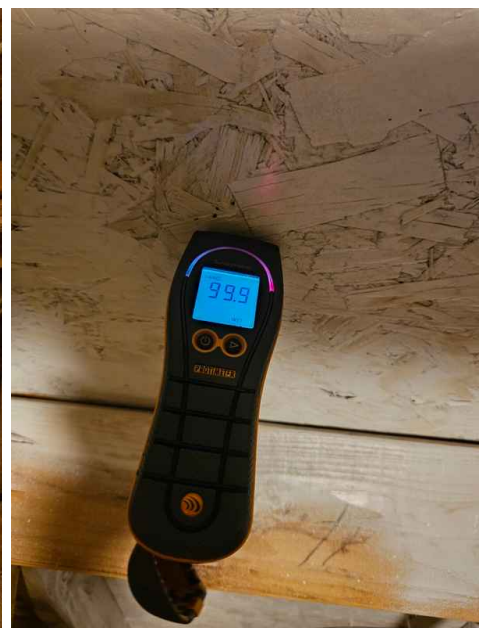
In the Attic

### ATTIC ACCESS INFORMATION: Attic Inspection Method & Pictures:

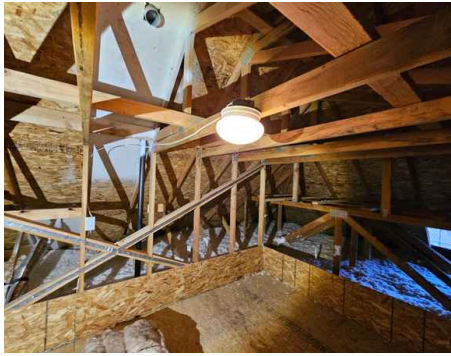
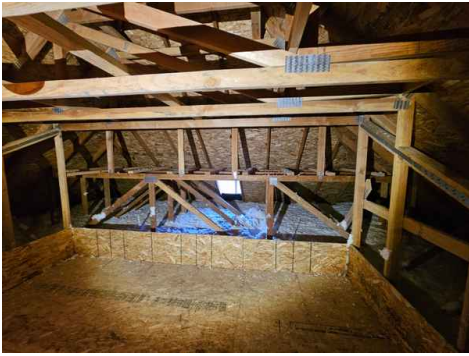
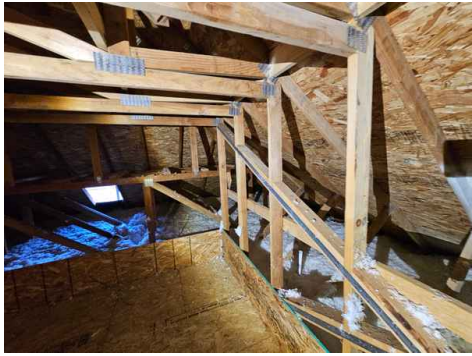
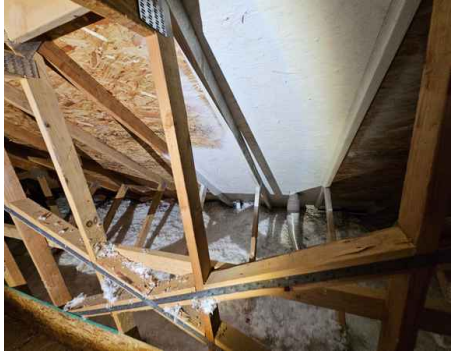
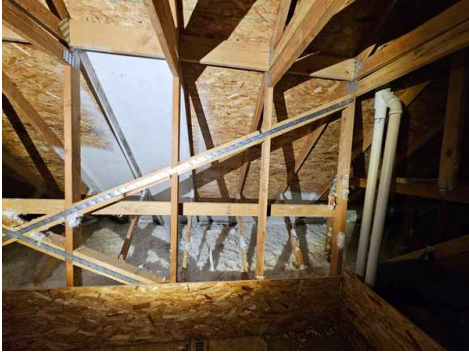
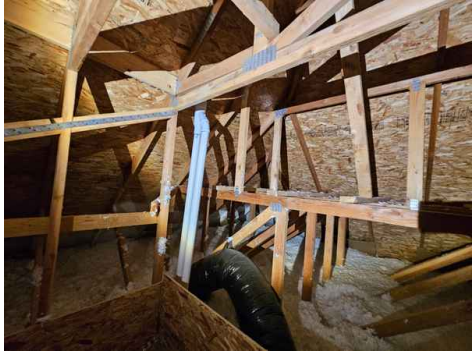
**ROOF STRUCTURE: Roof Framing**  
**Described Where Visible:**  
2x4 Trusses

**ROOF STRUCTURE: Roof**  
**Sheathing Described Where**  
**Visible:**  
OSB

**ROOF STRUCTURE: Roof Structure**  
**Condition Where Visible:**  
Satisfactory

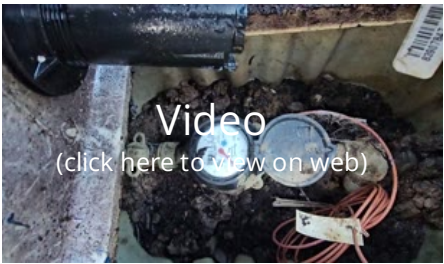
**F. Water Meter Checked for Motion & Video:**  
Completed
